ESCUELA SUPERIOR POLITECNICA DEL LITORAL

**"ANALISIS DE FALLAS DE LAS PLACAS DE
NIQUEL EN EL PROCESO DE IMPRESION DE
DOCUMENTOS DE SEGURIDAD"**

INFORME TECNICO

**AÑO
1994**

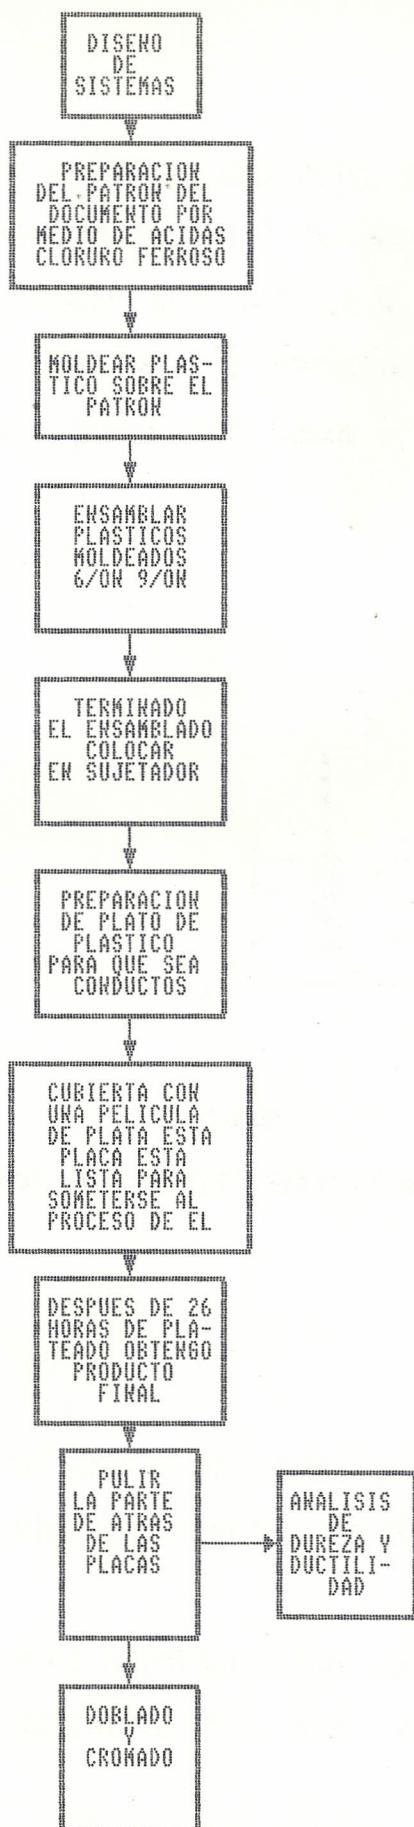
DIAGRAMA DE FLUJO DEL PROCESO ELECTROFORMADO

La solución requiere de sulfato de níquel ,Cloruro de Níquel, Ácido Bórico, Controlador de esfuerzos (Ácido Bencenico Disulfónico en sales de sodio). Este proceso produce depósitos de níquel que son particularmente aplicables a ingeniería .Como se demuestra en el siguiente diagrama de flujo

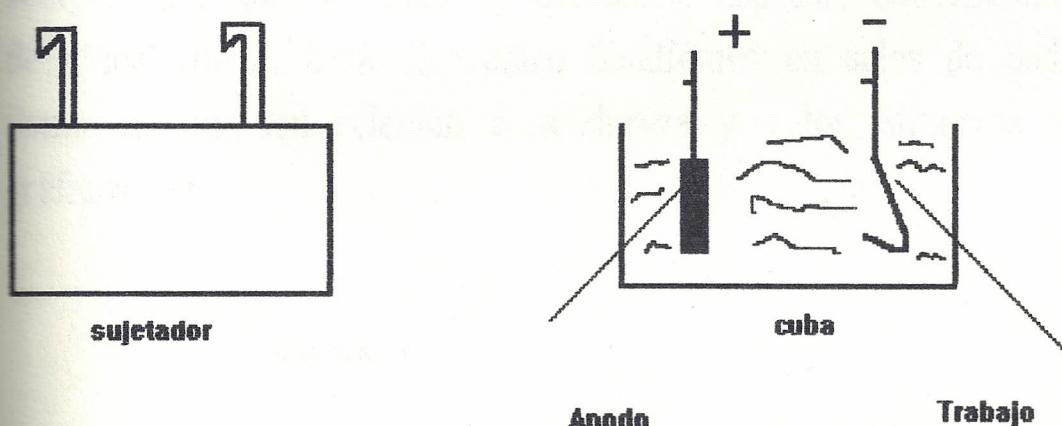
Para electroformado es necesario una cuba, un ánodo de Níquel y sujetadores. Una deseada cantidad de Níquel es plateada o depositada sobre el sujetador, que contiene la placa maestra que actúa como catodo, la cual ha sido previamente metalizada con un baño de Plata, este puede ser hasta 5/8 de pulgadas de espesor.

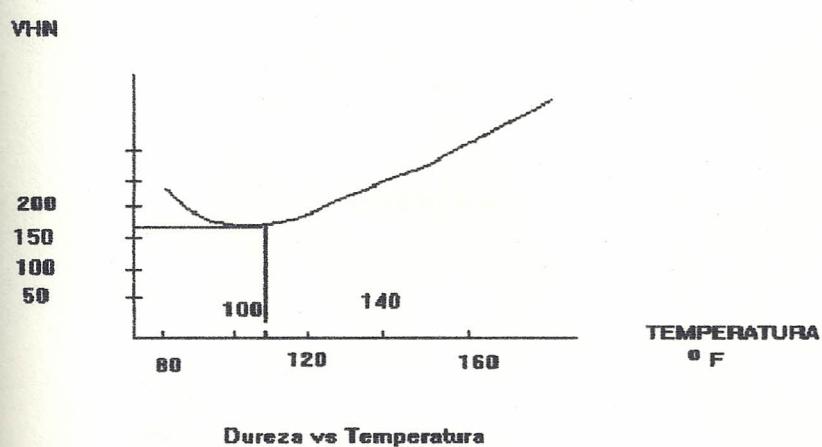
GRAFICA # 1

Níquel Suave : Con valores de 22- 25 Rockwell Escleroscopio que se obtiene disminuyendo el ph de la solución desde 3.8 a 2 añadiendo ácido Sulfámico (ver gráfico 1),

Temperatura, ph, Densidad de corriente, Espesor, Concentración de níquel metal, Ácido Bencénico Disulfónico en sales de Sodio. Como afectan con relación a la dureza y a los esfuerzos ver gráficas 1-6 .

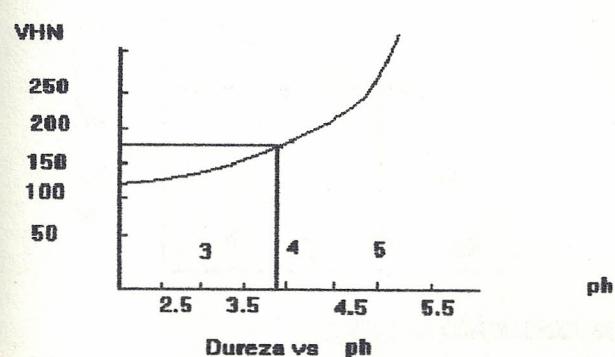
GRAFICA # 2

El Níquel medianamente suave (25-28 Rockwell Escleroscope) seria menos dúctil y maleable pero más resistente a ser rayado, este se obtiene añadiendo Benzeno Disulfónico Ácido en Sal de Sodio en una concentración de 2 onz/gal (ver gráfico 2).

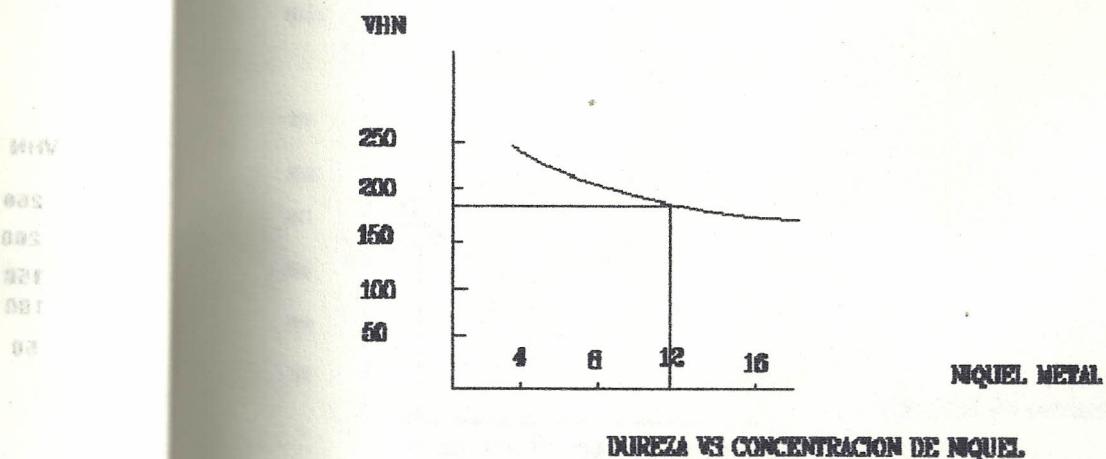
GRAFICA # 5

DUREZA VS CONCENTRACION DE NIQUEL.

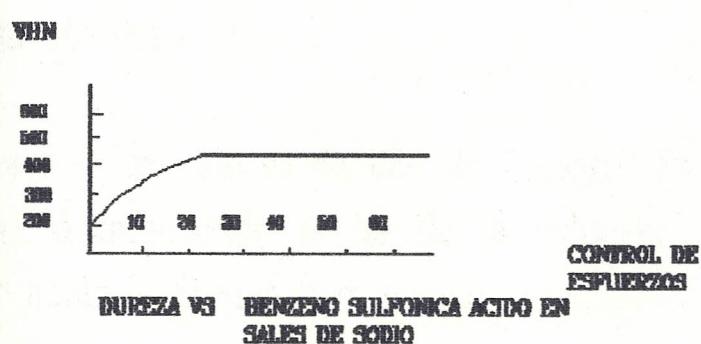
GRAFICA # 6

DUREZA VS BENZENO SULFONICA ACIDO EN
SALES DE SODIO

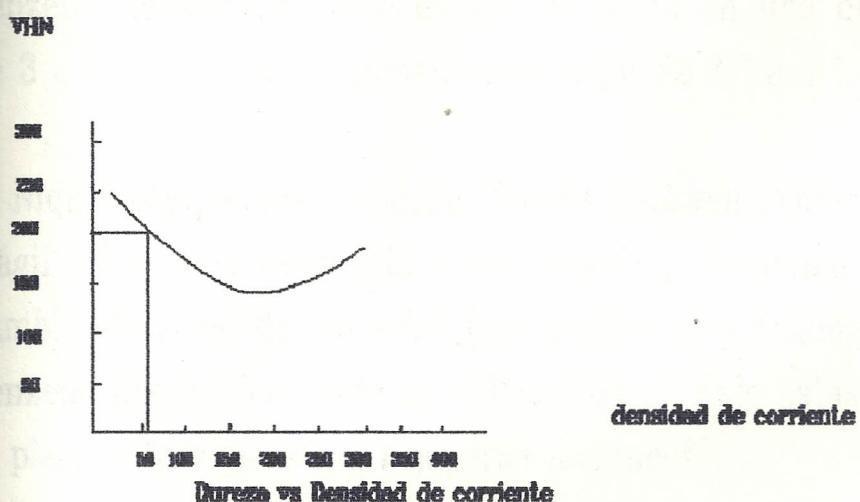
GRAFICA # 3

El Níquel completamente duro (34-40 Rockwell Escleroscope) muy frágil pero muy resistente a ser rayado y maquinado, se obtiene cambiando al ph de 3.8 a 5.2 (ver gráfico 3) y también añadiendo Benzeno Disulfónico Ácido en Sal de Sodio. Bajo estas condiciones la placa esta expuesta a romperse fácilmente.

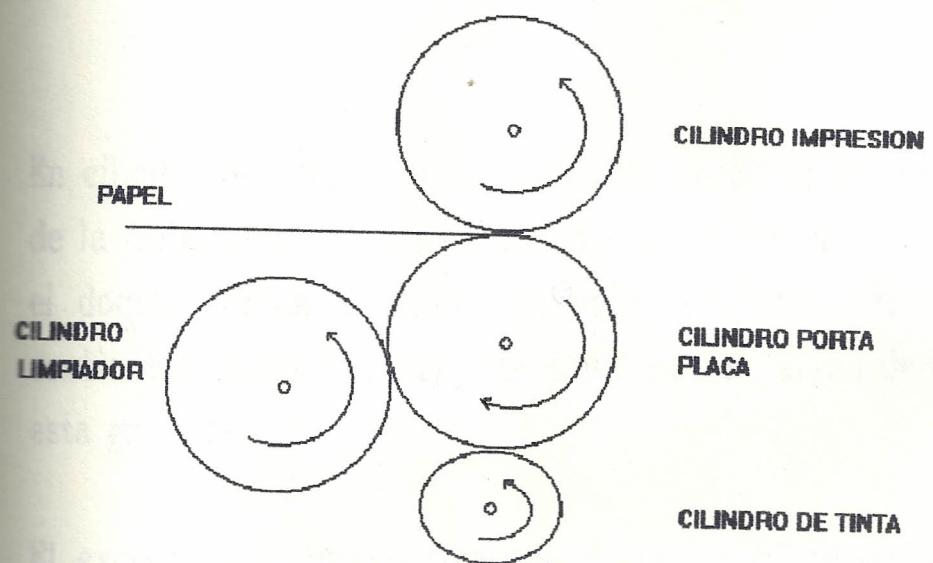
FIGURA 1

- Cilindro de grabado o impresión
- Cilindro de tinta
- Cilindro de limpieza
- Cilindro porta placa

Cilindro de grabado: contiene el papel.

Cilindro de tinta: provee de tinta a las placas en la parte del grabado.

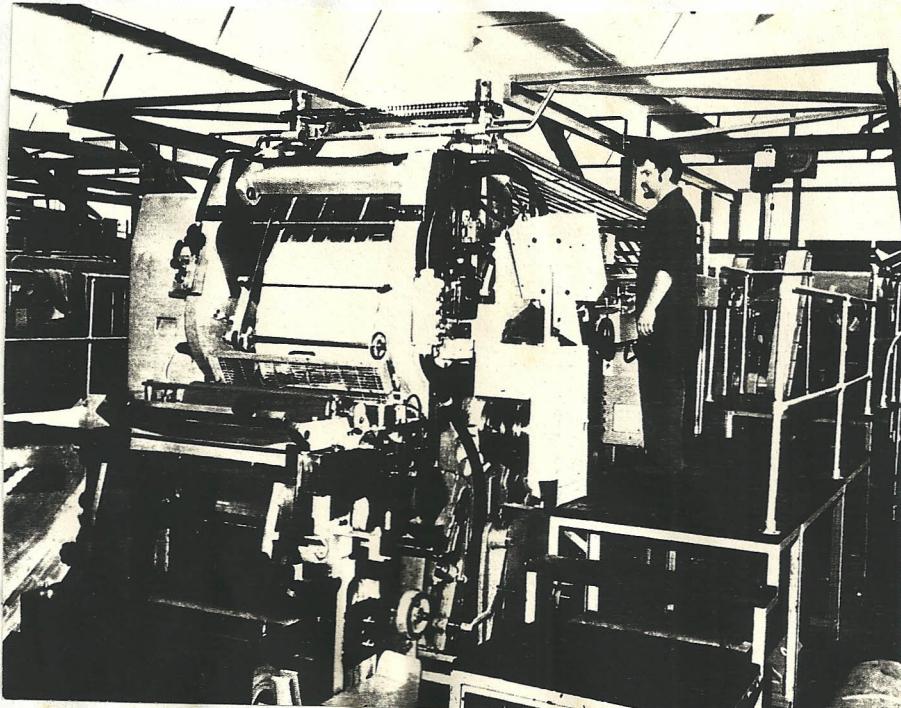
Históricamente las placas han presentado diferentes defectos que se identifican en las fotos que se indican a continuación.

Los parámetro de procesos pueden variarse de acuerdo a las gráficas 1-6 y así obtener valores óptimos .

El control de calidad se lo obtiene comparando los valores rutinarios con los valores óptimos de los parámetros, es decir dureza ,espesor y dimensiones.

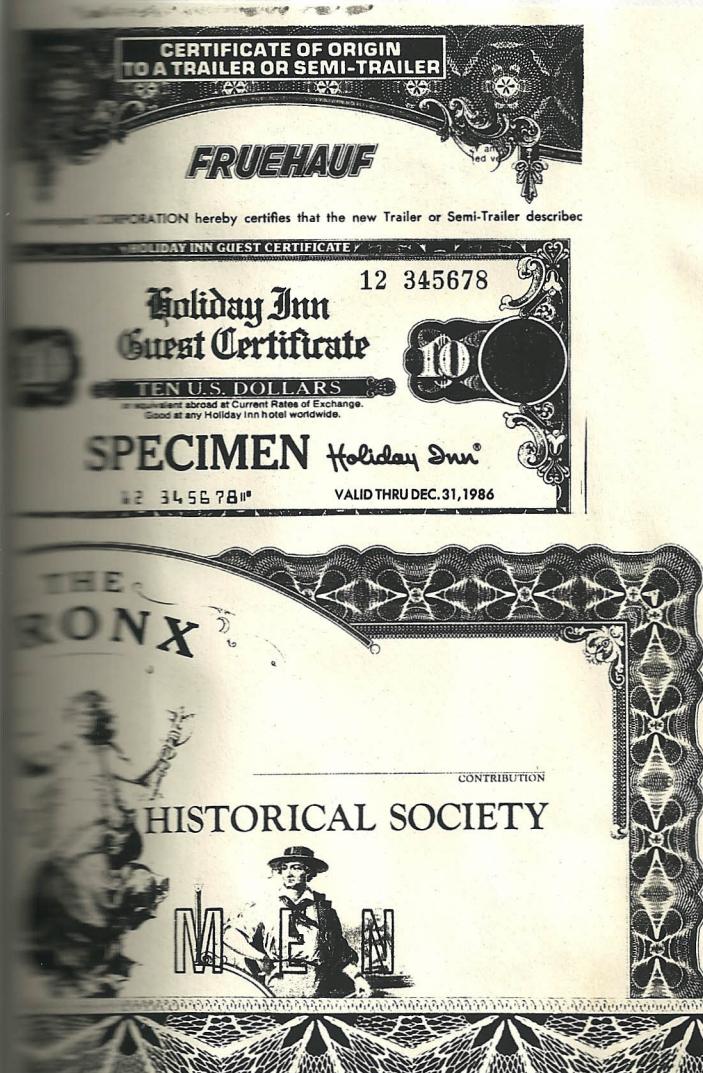
Como podemos observar en la siguiente foto la fractura de la placa de níquel deja su marca en el documento de seguridad, lo cual indica que debe cambiarse la placa de níquel.

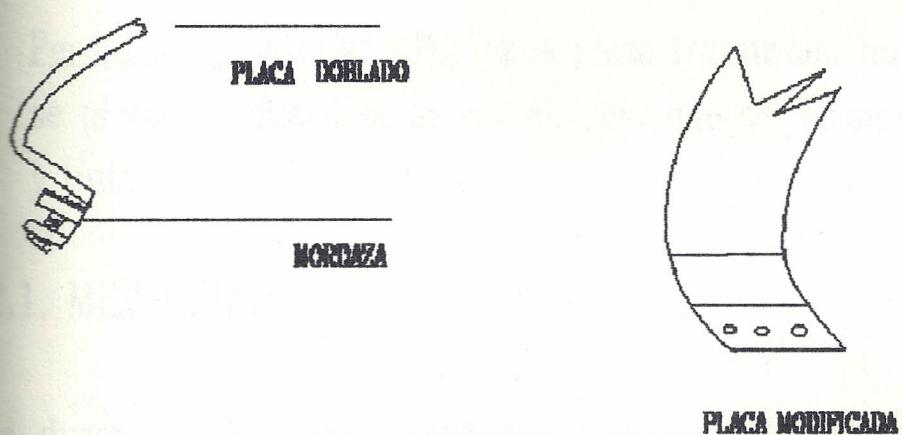
FIGURA 2

Diseño del cilindro : El diseño actual del cilindro consta de un sistema de mordaza de sujeción las cuales sujetan las placas del níquel como se encuentra en la siguiente figura 2.

Según el gráfico de la mordaza vemos que hay puntos donde se encuentran los mayores esfuerzos que podrían ser la causa de la rotura de la placa

Para evitar los máximos esfuerzos en el punto de contacto de las mordazas con la placa, es necesario diseñar un sistema de pines en el cilindro porta placa , con templadores que puedan asentar bien la placa sobre la superficie del cilindro, aplicando un torque de 25 lb-pie. ver Figura 7.

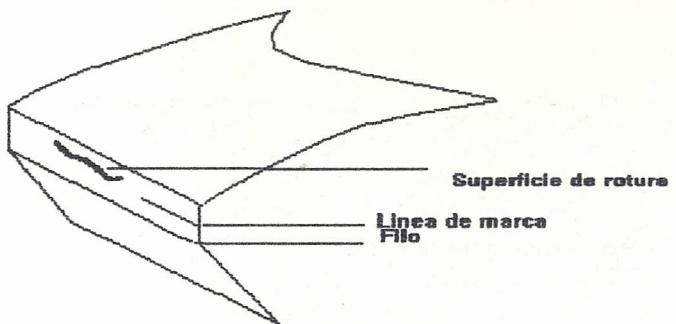
FIGURA 3

Examinando las placas, se encontró que en la superficie del Cromo hay muchas fisuras, y eran mayores en las partes donde se dobló la placa y en los lugares donde los radios de curvatura fueron más pronunciados. La mayor parte de las fisuras fueron alineadas perpendicular a la dirección del movimiento de las placas, también note que la mayoría de fisuras se encuentran a 1/4 del doblez de la PLACA.

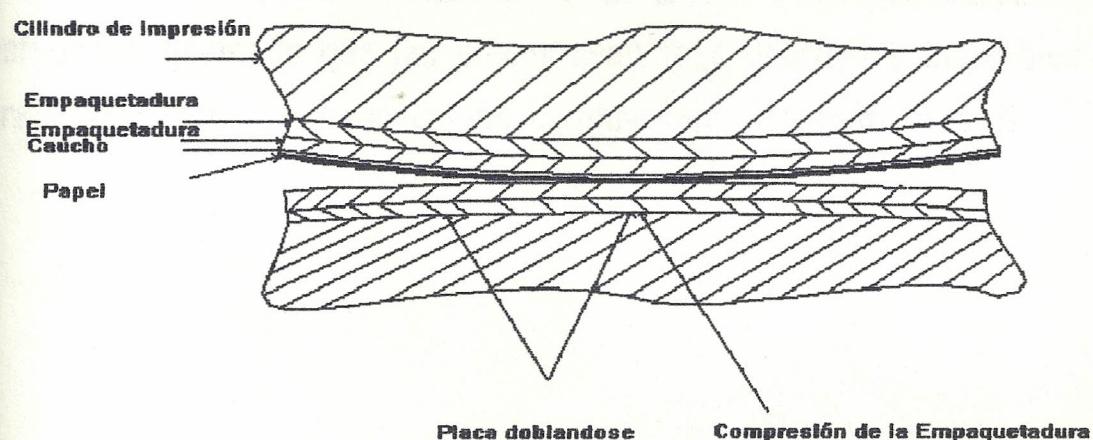
FIGURA 4

El esfuerzo promedio que aplique en la placa puede ir de 5000 a 30000 psi, dependiendo del espesor y del torque sobre los pernos. El esfuerzo promedio en una placa de 0.040 pulgadas de espesor con un torque de 25 lb-pie es aproximadamente 20000 psi. Este esfuerzo se incrementa durante el ciclo de impresión debido a la presión de contacto y encontré que este incremento es debido a la empaquetadura de cartón. (figura 4 y 5).

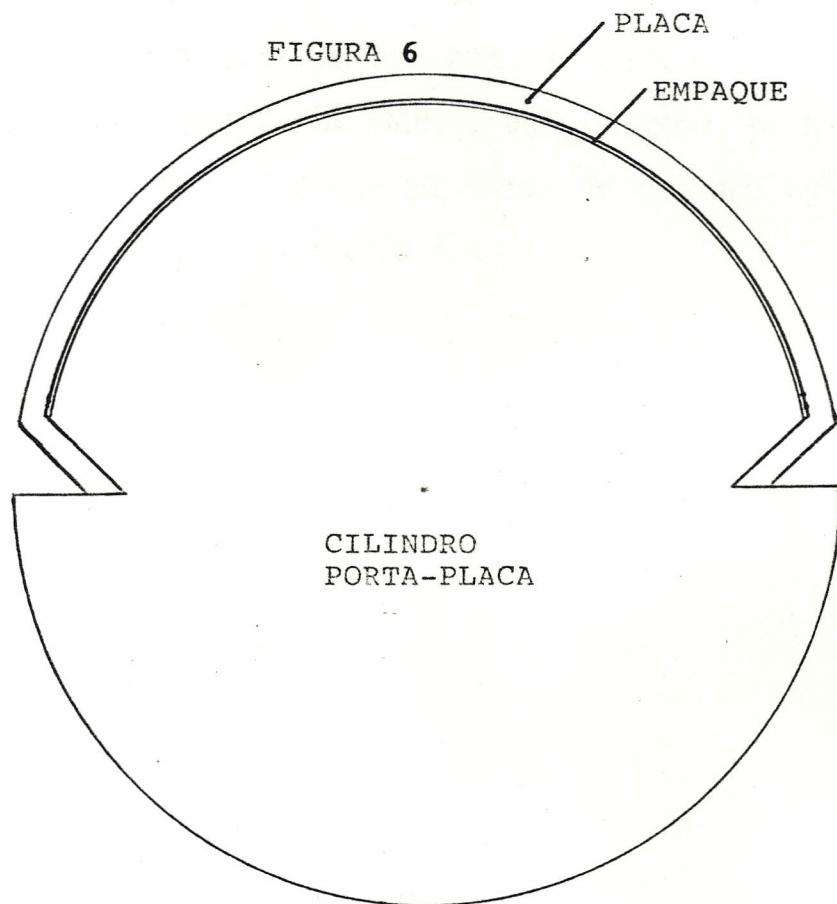
FIGURA 6

La placa es montada en el cilindro sobre una empaquetadura de cartón de 0.020 pulgadas y sujetada en los extremos por 2 mordazas, para evitar que la placa se mueva, el problema empieza aquí cuando los 2 cilindros (de impresión y porta placa) están en movimiento bajo presión , la empaquetadura se

comprime y se empieza a crear espacios vacíos entre la placa y la empaquetadura , provocando que se produzca fatiga de Níquel en los espacios vacíos como se muestra la Figura 5, también se producen los máximos esfuerzos entre los dientes de la mordaza que soporta la placa . ver Figura 2.

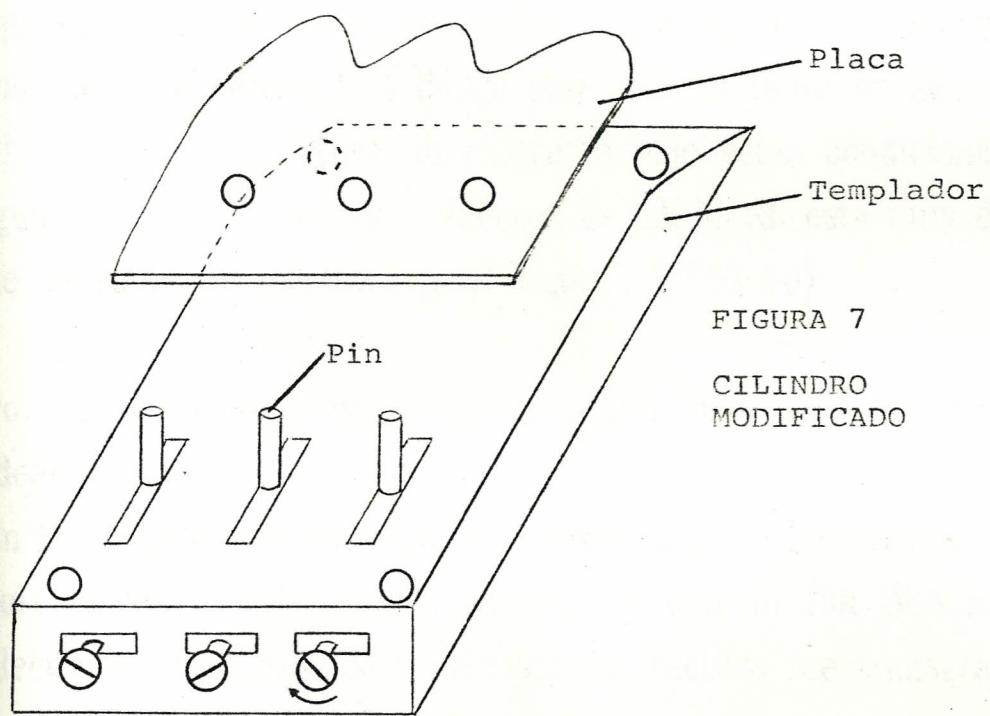
FIGURA 7
CILINDRO
MODIFICADO

Este sistema de pines reemplazaría a las mordazas, 3 pines en un extremo y 1 en el otro. En la placa tendría que perforar 4 huecos de $1/8 "$ de diámetro, y en los templadores se aplicó un torque de 25 lb-pie para una placa de espesor 0.040 pulgadas.

suficiente para mantener la placa asentada en el cilindro y que no se mueva, este torque creó aproximadamente un esfuerzo cortante de 20000 psi. Esto fue determinado experimentalmente en base a la experiencia.

El esfuerzo en la capa de Cromo bajo estas circunstancias es de aproximadamente 27000 psi debido a que el Cromo tiene mayor modulo de elasticidad (34000 psi) por lo tanto no se hallara ninguna fisura o rotura en el cromo bajo estas condiciones, de igual forma en el Níquel, esfuerzos de 20000 psi esta muy debajo de los esfuerzos que soporta el Níquel (95000 psi) .

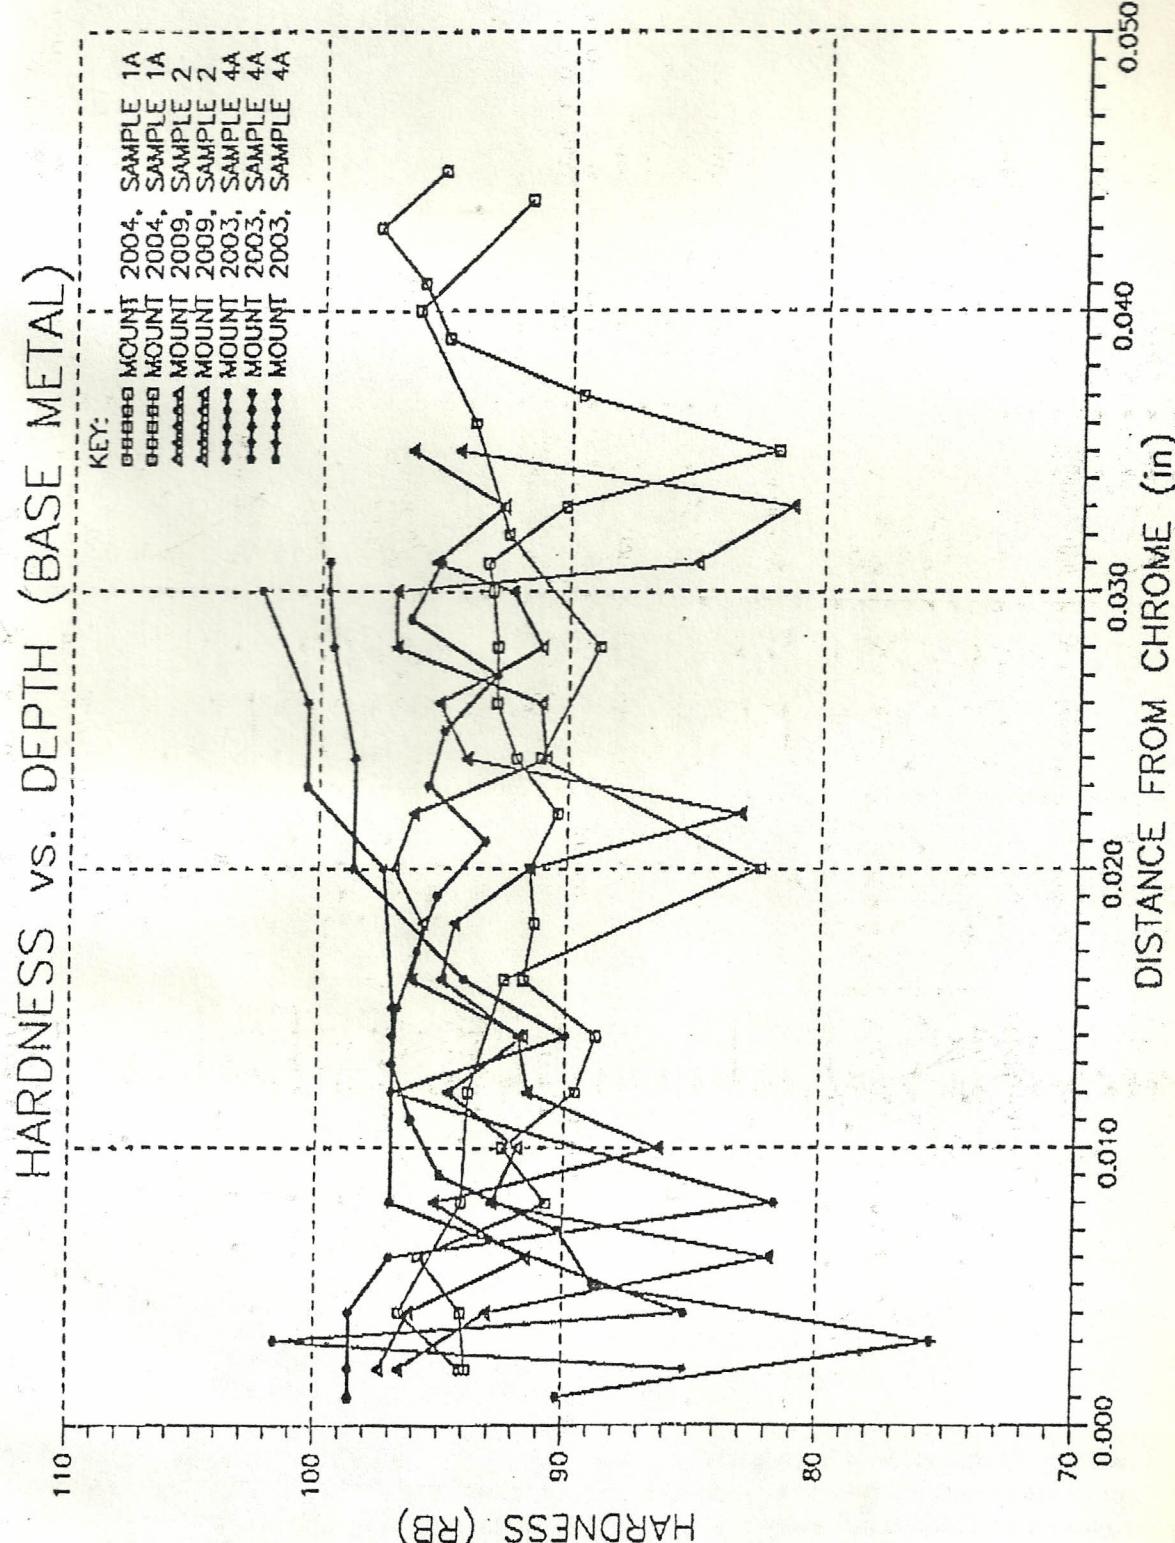
Figure 1. Shown above is a graph of hardness vs distance from the chrome plating (outer surface). This graph shows no discernable difference between plate 1 (long life) and the other plates (short lives). This graph also shows that the average hardness of the plates is acceptable.

There was no discernable difference in either microstructure or hardness between the long-lasting plates and the short-life plates which we received. Both microstructures were columnar.

The metallurgy of the plates is not believed to be a cause of the cracking problem. The hardness of the nickel was checked and found to be acceptable.
