## REPLANTEO DE CURVA HORIZONTAL # 7 IZQUIERDA

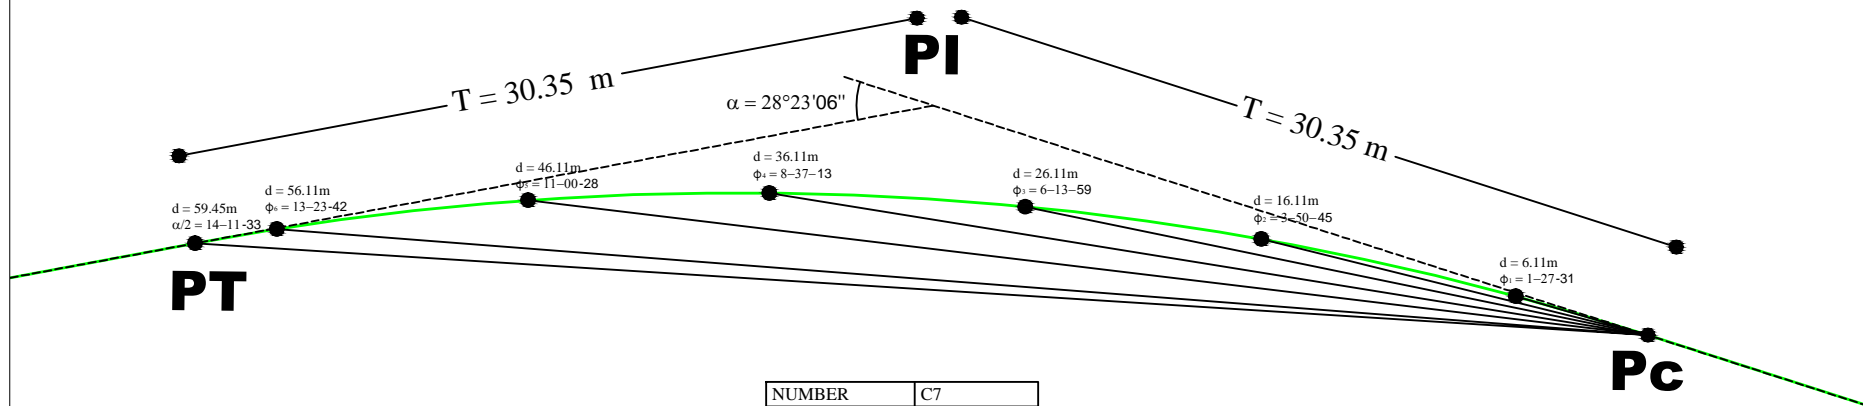
NUMBER	C7
DEFLEXION	28-23-06
RADIO	120.00
LONG. CURVA	59.45
EXTERNAL	3.78
TANGENTE	30.35
